17 June 2015
ET120054

Re: Moosehills Road Grade Failure - Scope and Cost Estimate for Engineering Services

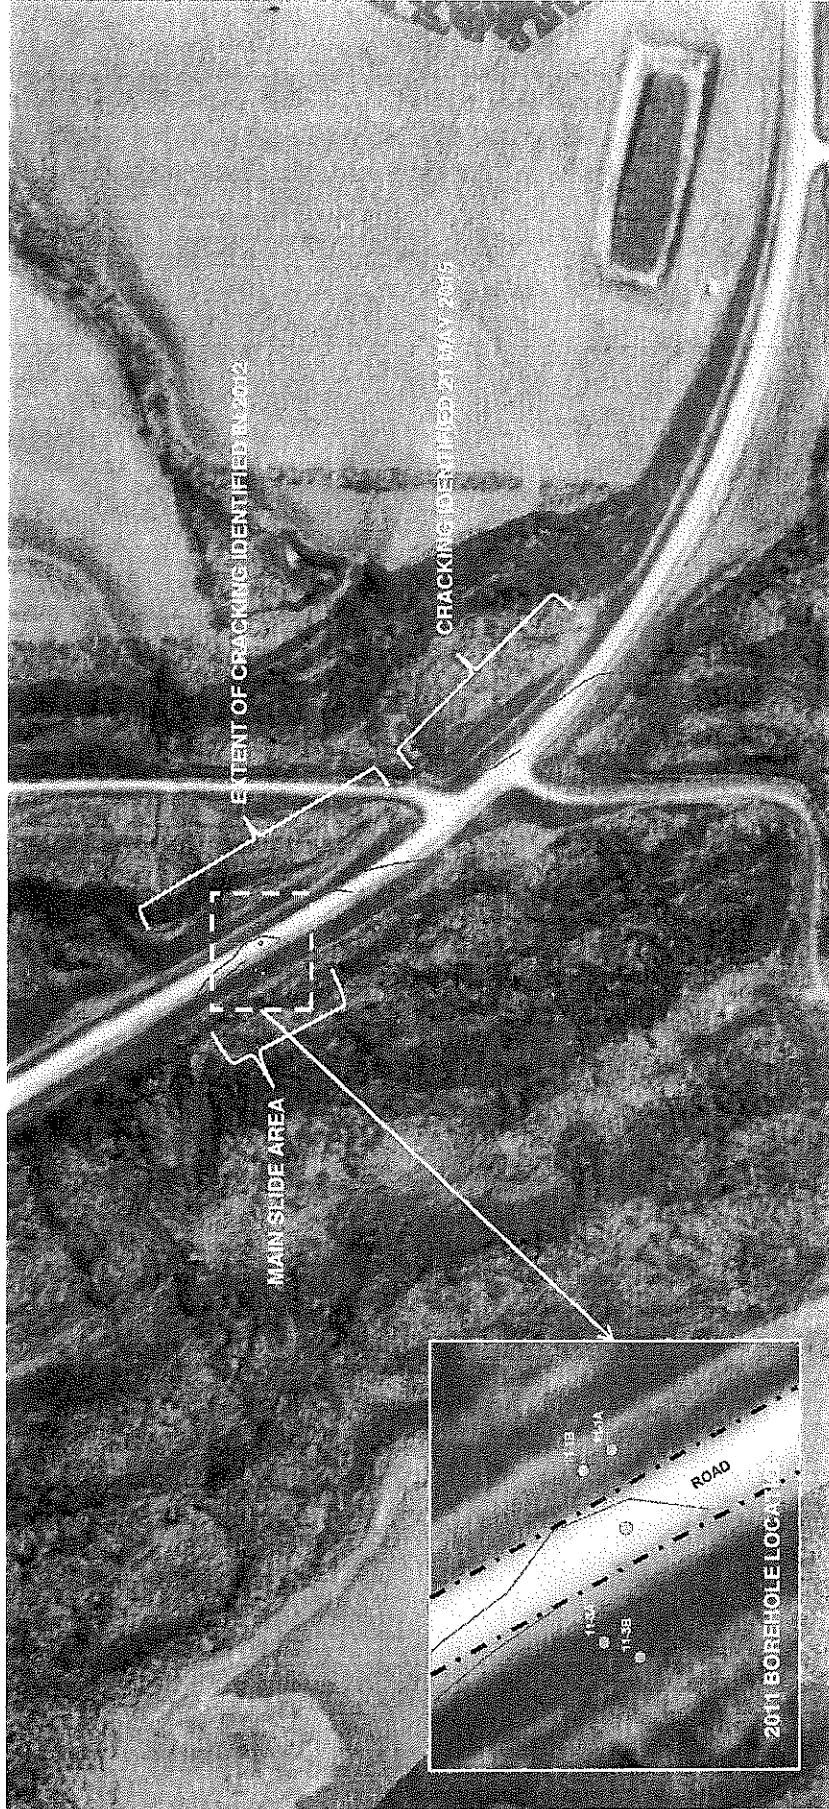
- A total of 5 boreholes were advanced in the immediate vicinity of the main slide area, within the upslope ditch and on the downslope embankment. The main slide area is shown in Figure 1. Three pneumatic piezometers and three slotted piezometers were installed to measure groundwater levels. Two slope inclinometers were also installed (shown in Figure 1).

The extent of cracking on the road was mapped with a hand-held GPS during the site visit and is shown in Figure 1. The extent of the main slide area was found to be similar to that reported in 2012, however additional cracking not reported in 2012 was identified on the road up to 170 m south-east from the main slide. Based on these observations, the total length of affected roadway is estimated at approximately 350 m. Some of the cracks extended downslope on the embankment. There were no obvious signs of toe bulging at the toe of the embankment.
