# Speed Limit Review

## *Extension of 80 km/h speed zone near the hamlet of Ashmont*

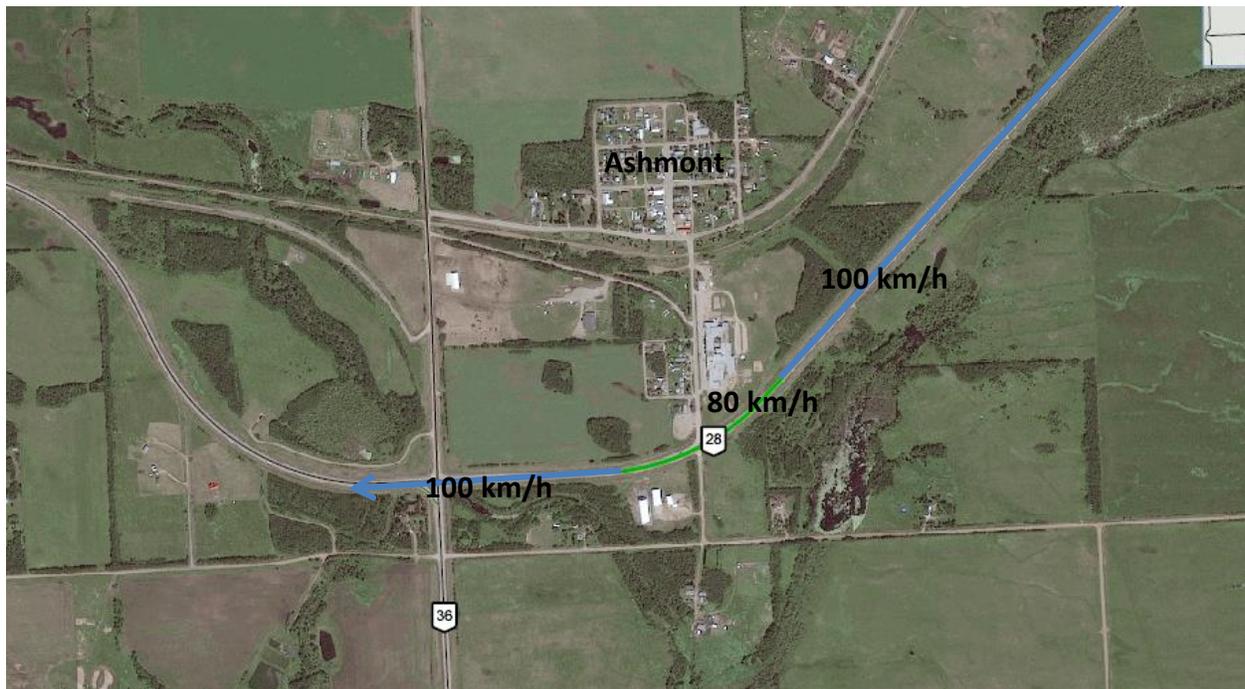
*Figure 1: Current speed gazettement on Highway 28*

The current 80 km/h zone ends at km 0.460, which is approximately 200 metres west of the main access to the hamlet of Ashmont. At km 0.460, continuing westward, the speed limit increases to 100 km/h, and there is a distinct change in roadway characteristics. The motorist has exited the horizontal curve, and there are no longer sight distance concerns. The vertical geometry is similarly satisfactory; the one

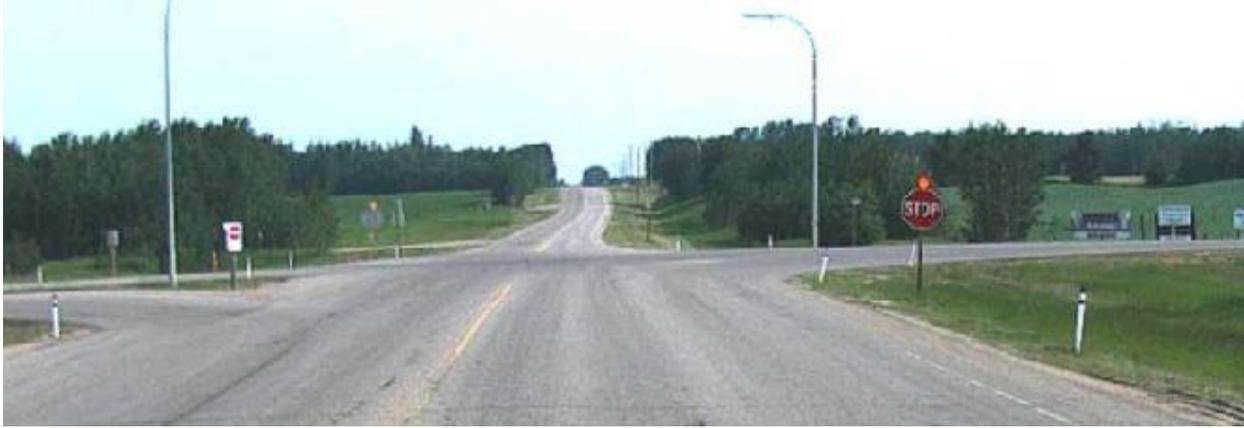
*Figure 1: View for NB vehicles on Highway 36 at the intersection. The stop sign is oversized and has a flashing red beacon mounted to the top.*

As the collisions at the intersection had similar causes, an analysis of the approaches was completed. At the intersection, there is a stop control for northbound and southbound traffic on Highway 36. The stop signs on Highway 36, which can be seen in Figure 1, are oversized and have a red flashing light mounted over the sign to provide drivers with additional warning. The signs are also preceded by an “Stop Ahead” warning sign (WB-1) and “Stop Ahead” pavement markings; even further back, an “Important Intersection Ahead” warning sign is applied and an information sign announcing the junction. For the vehicles approaching on Highway 28, there is an “Important Intersection Ahead” sign as well as an information sign to indicate that there is a junction with Highway 36.

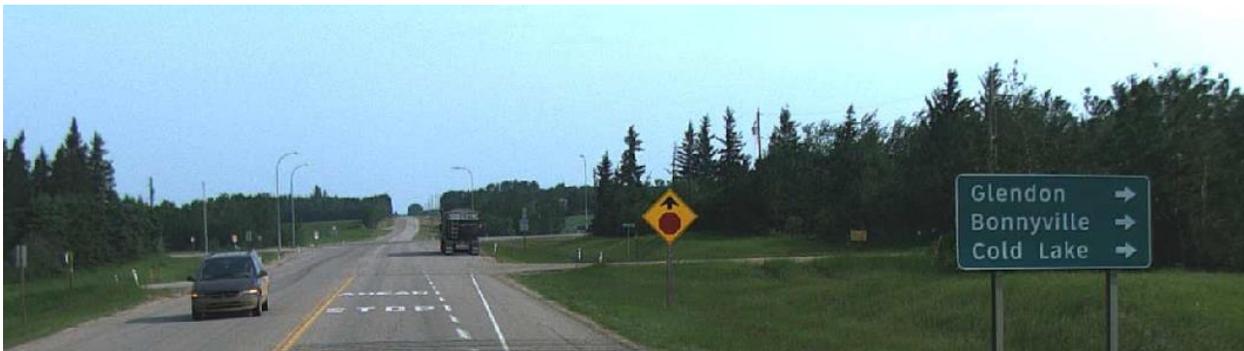
*Figure 2: View for Northbound Vehicles on Highway 36 Approaching Highway 28*

For southbound vehicles on Highway 36, the roadway is flat with no obstructions in sight distance. Northbound vehicles approach the intersection from a vertical crest curve; however, the “Important Intersection Ahead” is provided prior to the curve and there is still over 400 metres of sight distance once the vehicle exits the curve. Finally, the northbound vehicles may also have their vision obscured because there is a right-turn lane at the intersection; as can be seen in Figure 2, a vehicle sitting in the right turn lane can block the stop sign. However, the stopped vehicle in the right turn lane as well as the advance warnings should still provide adequate warning to drivers in the through lane.

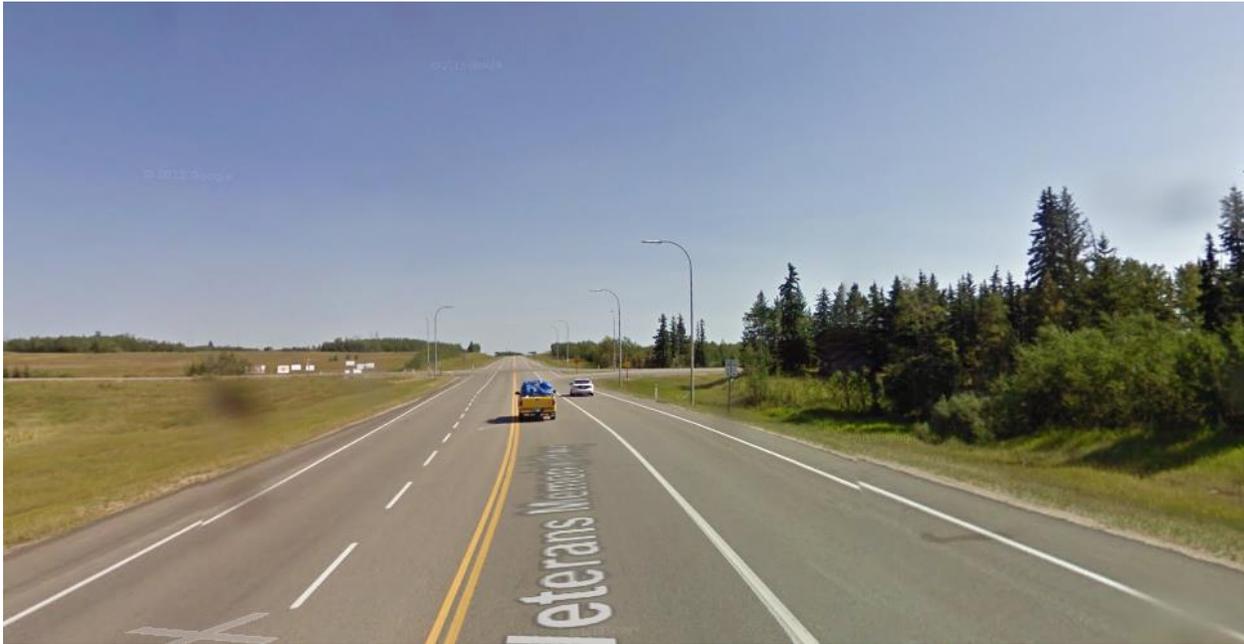
*Figure 3: View for EB vehicles on Highway 28 approaching the intersection*

For the vehicles approaching on Highway 28, the stopping sight distance is also adequate. As both eastbound and westbound vehicles approach this intersection, they are exiting a horizontal curve. From the westbound perspective, there is over 400 meters of sight distance. For eastbound vehicles, there is more than 200 meters, which is sufficient for a speed of 100 km/h. The eastbound sight distance can be seen in Figure 3. Since the signage and signage placement provided as well as the stopping sight distance from all approaches is adequate, there are no changes required at the intersection.
